Lamice DENGUIR, José OUTEIRO, Vincent VIGNAL, Guillaume FROMENTIN, Rémy BESNARD
- On the optimization of the cutting conditions for an improved corrosion resistance of OFHC copper - In: 8th CIRP Conference on High Performance Cutting (HPC 2018), Hongrie, 2018-06-25
- Procedia CIRP - 2018

8th CIRP Conference on High Performance Cutting (HPC 2018)

On the optimization of the cutting conditions for an improved corrosion resistance of OFHC copper

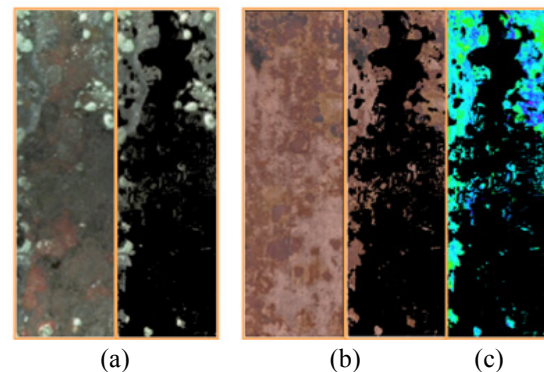
Fig. 1. Evaluation of the volume of copper dissolved by mm^2 covered by atacamite.

- Isolation of green zones (covered by atacamite) starting from a photo of the oxidized surface as shown in Figure 1a.
- Starting from the image of the cleaned surface, isolating topographies of zones corresponding to those covered by green before the cleaning as shown in Figure 1b.
- Visualization of the topography corresponding only to the filtered zones as shown in Figure 1c. Level 0 corresponds to the mean plan of the freshly machined surface, before the aging test ($R_a < 800\text{ nm}$).
- The program calculated the volume of copper that has removed (valleys) under the zones previously covered with atacamite, and divided it by the green analyzed surface, which gave a mean value of the depth of the dissolved substrate.

oxidation reaction per mm^2 covered by atacamite (the green color) was quantified. In fact, the oxidized surface was taken in photo by a high-resolution microscope *KeyenceTM*. Then, the surface was cleaned from oxides and taken again into photo. The topography was measured by optical microscope *AliconaTM* using the variation of focal distance technique. The volume of *OFHC* copper that disappeared from the oxidized surface was calculated by treating automatically the images under *Matlab[®]* (cf. Figure 1) using a script developed for the study making the following tasks:

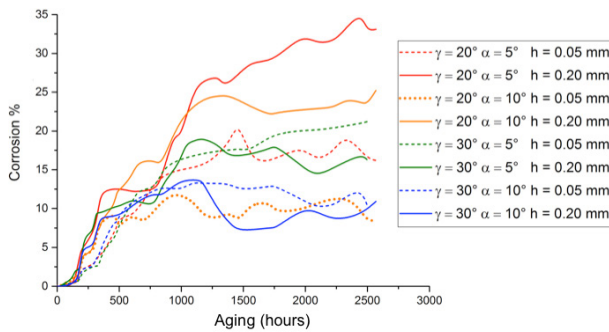
Fig. 2. Corrosion evolution under saline atmosphere for surfaces obtained by orthogonal cutting at $V_c = 90$ m/min.

Figure 5 shows a non-negligible influence of the cutting conditions in on the evolution of the corrosion of *OFHC* copper surfaces, especially after 700 hours, under saline atmosphere. In fact, for the surfaces generated with a tool having the same rake angle of 20° , a raise in the uncut chip thickness accelerates the corrosion (cf. Figure 2). Nevertheless, this phenomenon is not seen when the rake angle is 30° where the uncut chip thickness seems to have no influence. On the other side, whatever the rake angle and the uncut chip thickness are, the raise of the flank angle from 5° to 10° shows a better influence on corrosion resistance. As observations are not enough to reveal the existing relationships between the cutting conditions and corrosion resistance, further analysis is needed to reveal their impact on the surface integrity responsible for this behavior.

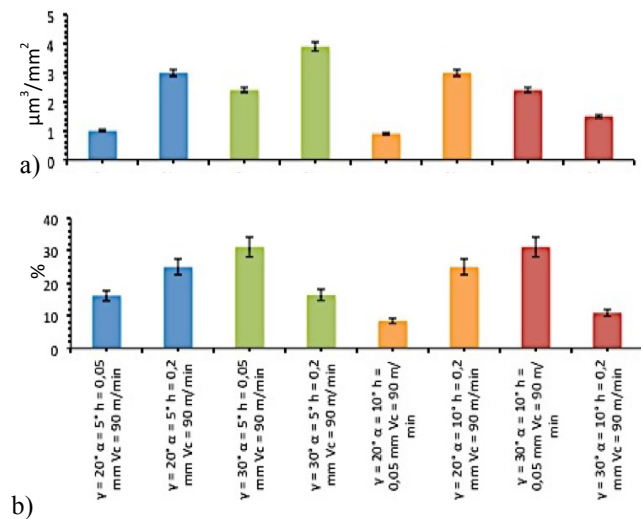
To explain degradation under the green surface, in-depth topography is measured under the oxide once it is removed. The removed volume per surface unit reflects the mean in-depth degradation under the oxide. Results are represented in Figure 3.

Fig. 3. (a) Mean in-depth degradation induced by oxidation at the end of the aging test under saline atmosphere, and (b) percentage of the oxidized surfaces at the end of the aging test under saline atmosphere.

Comparing the percentage of oxidized surface at the end of the aging test under saline atmosphere (cf. Figure 3b), the following remarks can be drawn: i) The least covered surface by atacamite is the least damaged under the green oxide ($\gamma = 20^\circ$; $\alpha = 10^\circ$; $h = 0.05$ mm; $V_c = 90$ m/min); ii) The most covered surface by oxides is not necessarily the one knowing the worst in-depth degradation ($\gamma = 30^\circ$; $\alpha = 5^\circ$; $h = 0.05$ mm; $V_c = 90$ m/min).

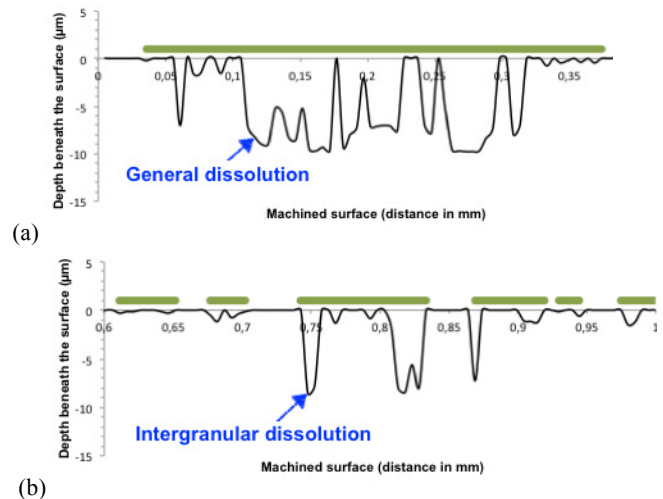
A unidirectional profile measured in the oxidized region was taken from every analyzed surface to identify the shape profile under the oxide. It was measured only under the green areas (represented by the green lines in Figure 4 as an example). The used in-depth resolution is 78 nm and the horizontal resolution is 5 μ m. According to the obtained profiles, it is remarkable that under the green areas two types of cavities can prevail: large cavities with plate valleys (corresponding to generalized dissolution, cf. Figure 4.a) and thin and deep cavities (corresponding to intergranular corrosion cf. Figure 4.b) in the borders of the green area.

Fig. 4. Profiles under the green zones for surfaces obtained by the conditions $\gamma = 30^\circ$, $\alpha = 5^\circ$, $h = 0.2$ mm and $V_c = 90$ m/min. Part of the analyzed profile presenting generalized dissolution (a) and intergranular corrosion (b).

The cavities depth varies under the surfaces covered by the green oxide, what witnesses a non-uniform dissolution happening on the same surface. These observations under the oxides allow the corrosion process analysis explaining the surface damage in the presence of saline atmosphere as follows [12]. Inside the droplets, copper dissolution leads to the formation of the ions Cu^+ or Cu^{2+} in aqueous solution. Associated to anions Cl^- already present in the droplet, they constitute the green compound CuCl . With high chloride concentration, they can even produce the ions of CuCl_2^- . On the other side, cations Cu^{2+} can be hydrolyzed to form atacamite $\text{Cu}_2(\text{OH})_3\text{Cl}$. This reaction, consuming molecules of H_2O , produces protons H^+ , decreasing the pH. As the droplet stagnates in the surface, the pH diminishes with the generation of atacamite. A previous study [11] has demonstrated that pH lower than the limit of copper dissolution can be rapidly reached leading to a generalized dissolution and to intergranular corrosion. The electrons issued from the dissolution reduce the oxygen inside the droplet. As the solubility of oxygen inside water is high, the cathodic reaction continues, and the dissolution evolves into cavities. Then, what makes a machined surface more active than the other just by manipulating the cutting conditions?

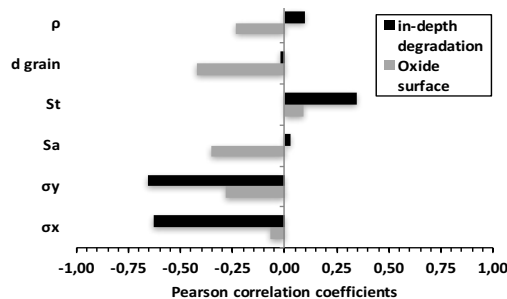
Fig. 5. Pearson correlations between the surface integrity measured parameters and the in-depth degradation and oxide surface at the end of the aging test in salt fog atmosphere.

To answer that question, the relationship between the surface integrity parameters (surface residual stresses in the cutting direction σ_x and in the transversal direction σ_y , the roughness S_a and S_t parameters, the grains size d_{grain} and the dislocations density ρ , all detailed in Table 1) and corrosion in terms of the oxide surface area and the surface in-depth degradation are evaluated using the correlation of Pearson technique. The results (cf. Figure 5) show that concerning to the area of the oxide surface is highly sensitive to the grain size d_{grain} , then to the surface roughness S_a , while in-depth degradation is mostly related to the residual stresses. In fact, the preferential dissolution starting sites are the grains boundaries and the peaks of roughness presenting micro-electrodes. So, more grains and more peaks imply greener surface. However, when it is up to the in-depth degradation, tensile stresses will play the major role in continuing and accelerating the dissolution process [12].

As S_a , d_{grain} , σ_x and σ_y are the surface integrity parameters identified as the most relevant in this study of the machined surfaces corrosion according to Pearson's correlation coefficients, the analysis of variance *ANOVA* revealed their relationship with the tested cutting conditions via Fisher indexes, as shown in Table 2. The highest Fisher index related to the roughness S_a is attributed to the flank angle α . In fact, unlike the turning operation where the combination of tool geometry and cutting parameters (in particular the feed) generates feed marks, in orthogonal cutting the machined surface is theoretically flat. However, small tool flank angle generates more friction between the tool flank face and the machined surface, resulting into build up and micro-tearing in the later. As a consequence, the value of S_a raises. Concerning to the residual stresses they are clearly driven by the uncut chip thickness. Indeed, while raising the uncut chip thickness, the residual stresses resulting from the mechanical loading cycle are more tensile [13]. However, concerning to the grains refinement, the impact of the cutting conditions is more complicated, as this phenomenon seems to be sensitive to the interaction of the different parameters.
